Case 12289

Urinary bladder rupture as demonstrated on CT cystogram

Published on 25.11.2014

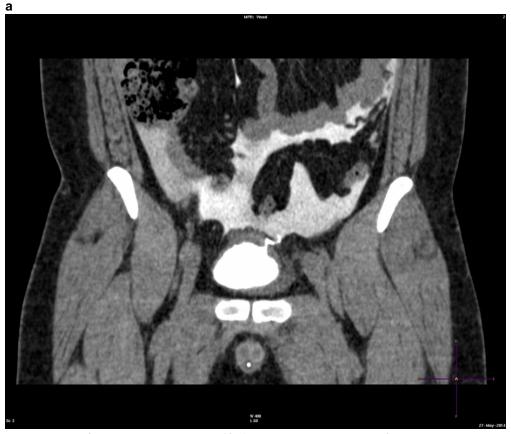
Figure 1

Description: Computed tomography (CT) retrograde cystogram: Coronal plane view demonstrating a significant defect to the left side of the dome of the bladder. There is extensive intraperitoneal contrast extravasation. **Origin:** Department of Radiology, New Cross Hospital, Wolverhampton, U.K

Therefore a CT cystogram (Fig. 1) using water-soluble contrast diluted in saline to 50mgl/ml was performed, demonstrating a sizeable defect to the left side of the dome of the bladder with extensive intraperitoneal contrast spillage.

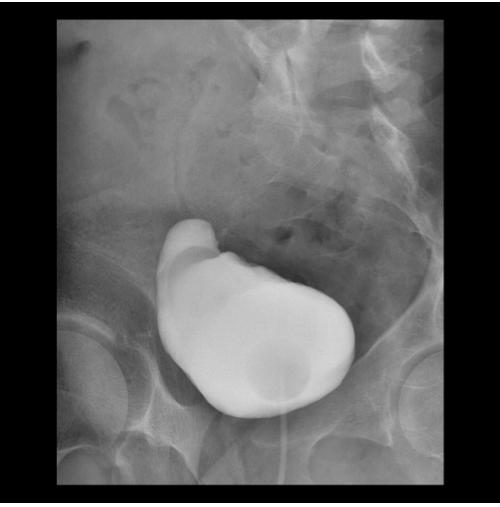
Figure 2

Description: Post-operative retrograde cystography illustrating an adequately distended bladder. There is absence of intra-abdominal contrast leakage, contour defects and filling defects. **Origin:** Department of radiology, New Cross Hospital, Wolverhampton, U.K

The patient underwent laparotomy and repair of ruptured bladder on the same day. One month after repair he underwent cystography (Fig. 2) with urografin contrast and a Foley's catheter in situ. This confirmed absence of contrast intra-abdominal extravasation, signifying successful bladder repair.
